RSC9 @ Genting

Permanent Soldier Pile Wall with Soil Nail Tie Back

(By Ir. Oh Chin Wah, Executive Director and Ms. Carmen Ngio, Design Engineer) (2015 Apr-Jun)

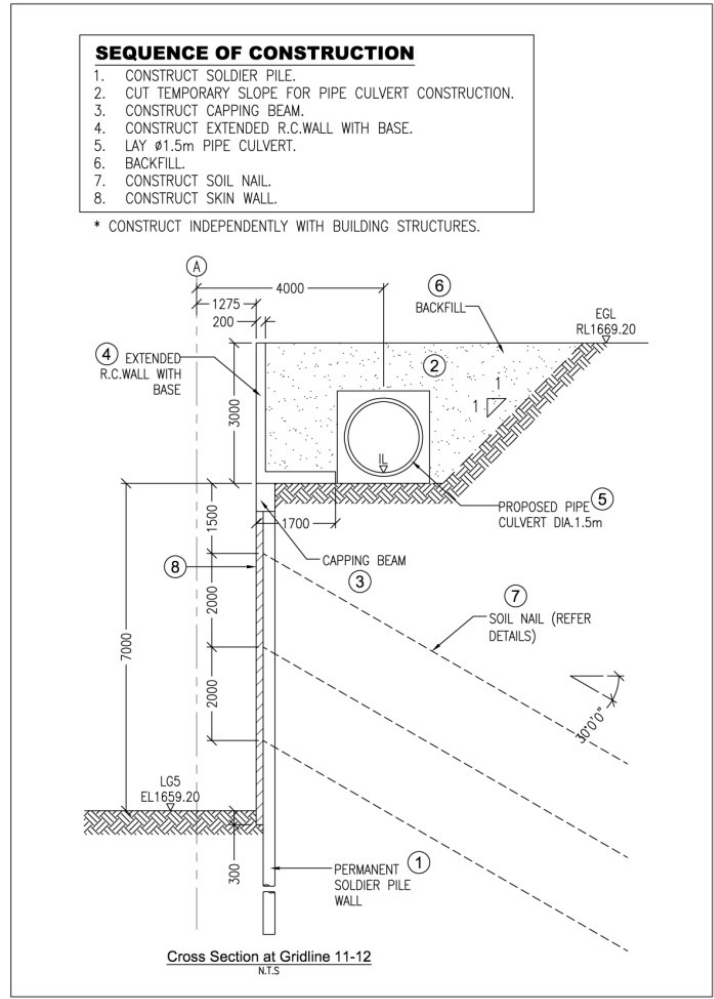
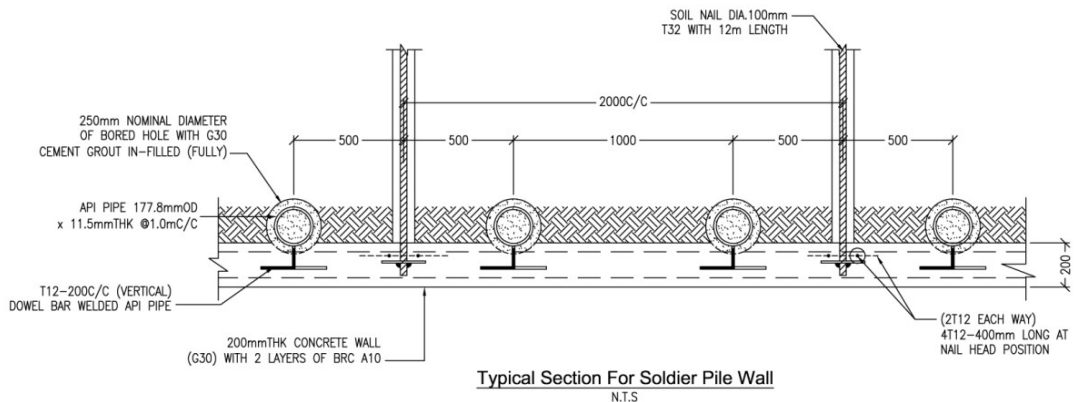
Permanent Soldier Pile Wall with Soil Nail Tie Back along G/L A

The design of this soldier pile wall is to facilitate the temporary excavation of the drain culvert installation, as well as the basement wall excavation up to maximum height of 10m. The original design of open slope excavation is not applicable in this case because of the close proximity to the main road. In order to overcome the slenderness of the soldier pile and to expedite the excavation work, multilayer soil nail tie back was adopted in this case which act as temporary support of the wall before the final strutting from the floor slab.

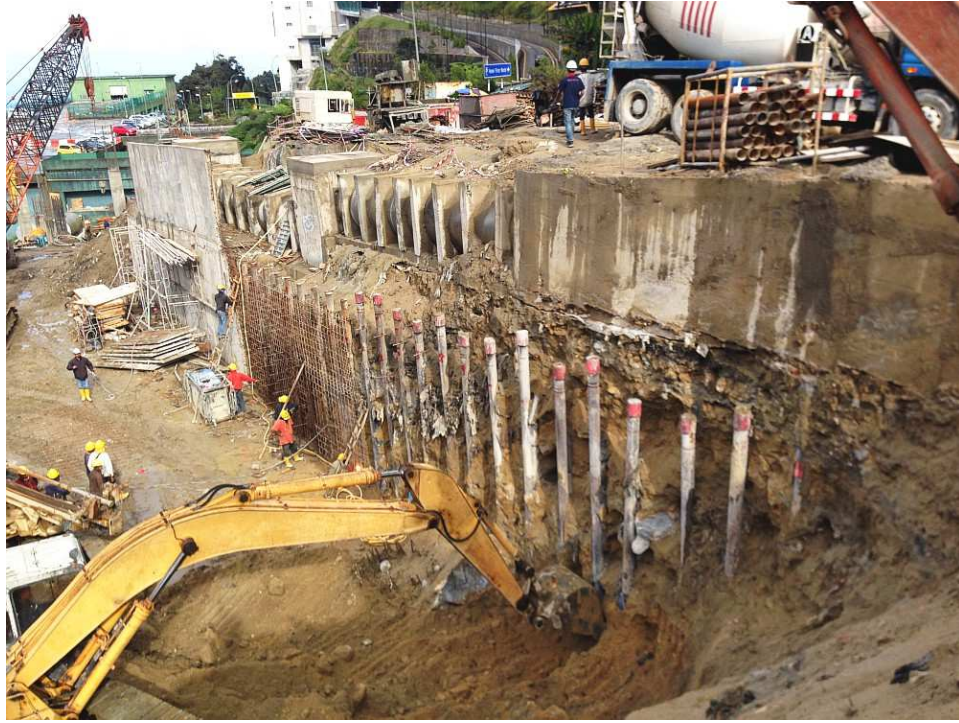
Wall in Construction

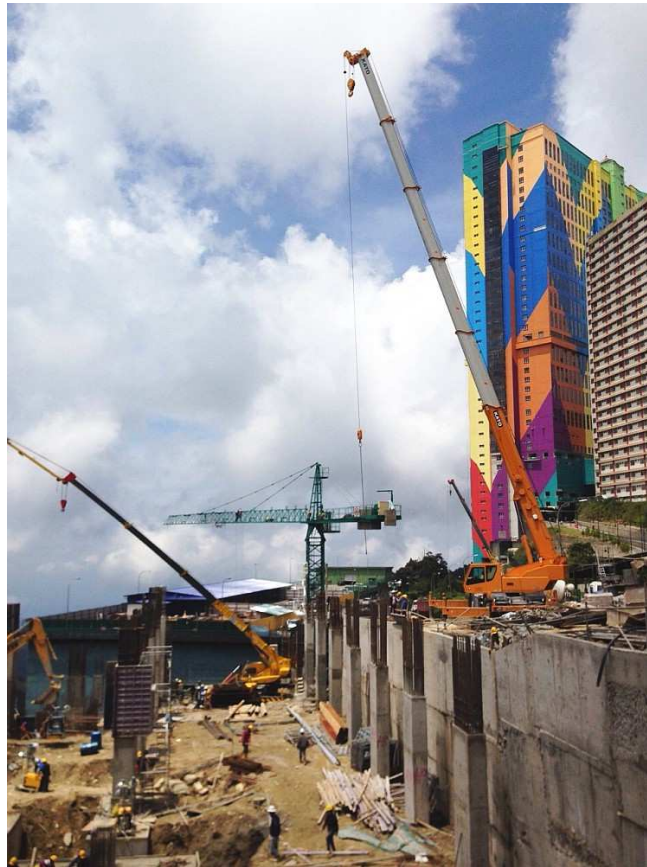
Completed Wall
