## GPO Bridge @Genting

### The Key Challenges and Solutions on GPO Bridge Construction

(By Mr. Patrick Lim, Project Engineer) (2016 Jul-Sep)

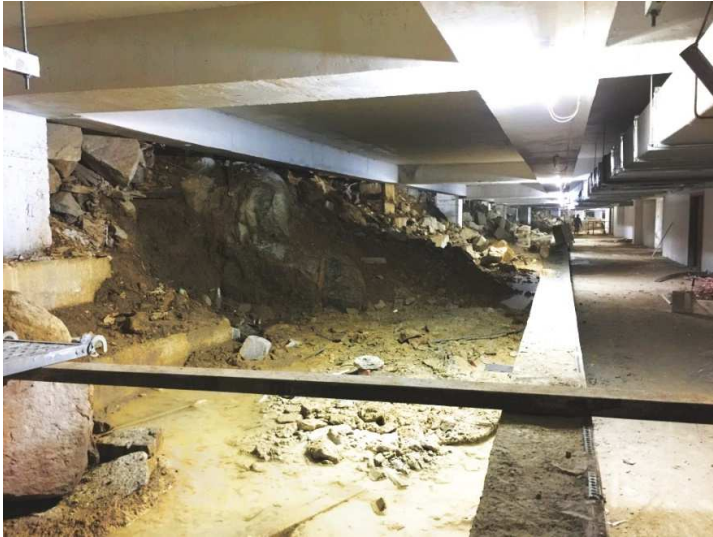
3. To construct 320m RC drain on a high bedrock level. It took us 4 months to complete. The RC drain due to head room limitation and massive rock hacking works by manual hacking. All concrete and disposal were also carried out and transported by manual.

High Bedrock Level along RC Drain Alignment

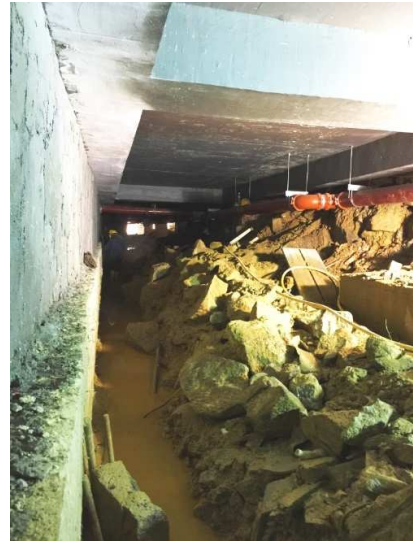
Massive Manual Rock Hacking

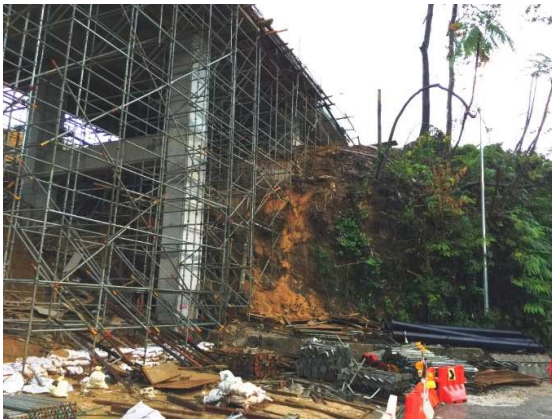
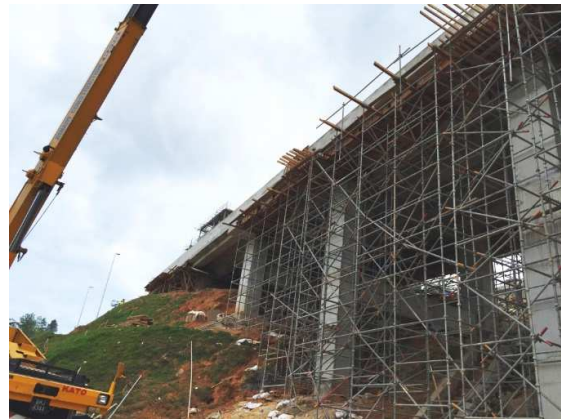
4. Another key challenge was to construct the RC deck on valley (Deck 2) and a sloping terrain (Bridge 2). Due to the nature of the terrain, the platform for scaffolding erection was of varies level and hence platform level adjustment was required. Extra precaution and efforts have been put in to ensure stability of the base of the scaffold.

RC Deck 2 Construction on Valley

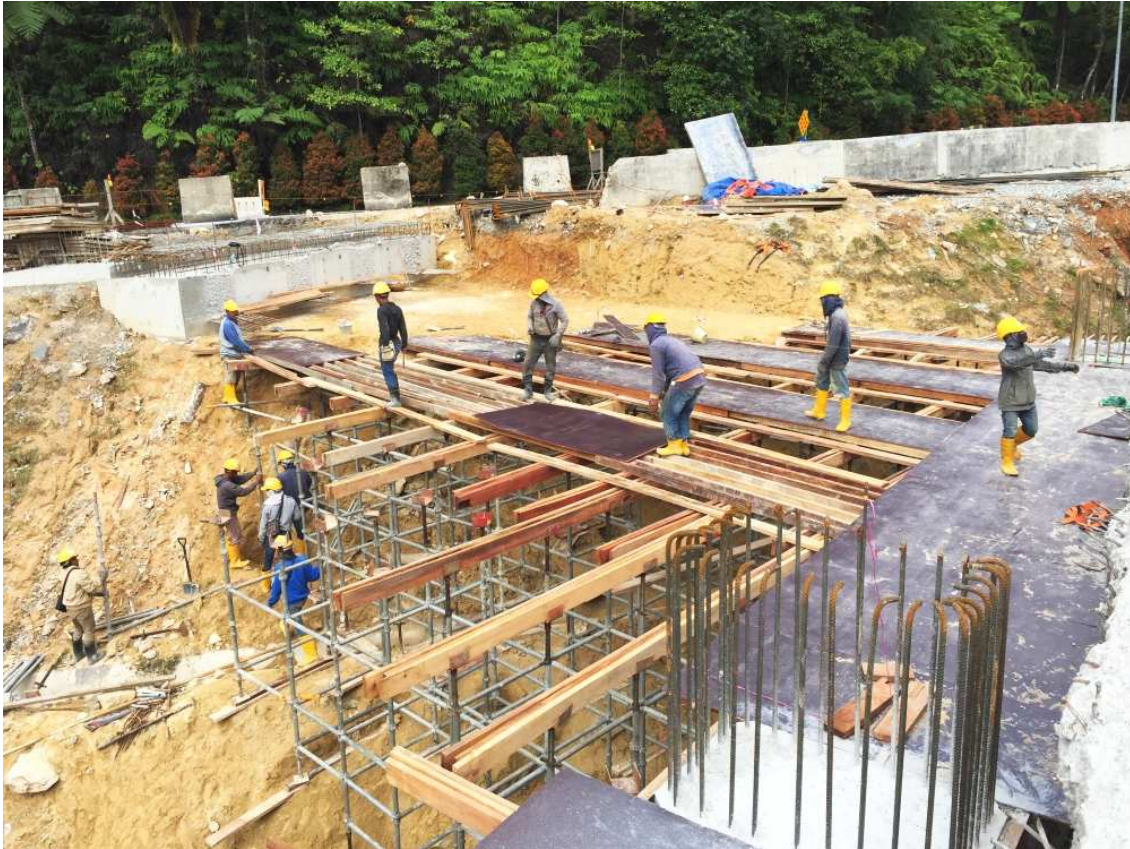
Bridge 2 Construction on Slope Terrain

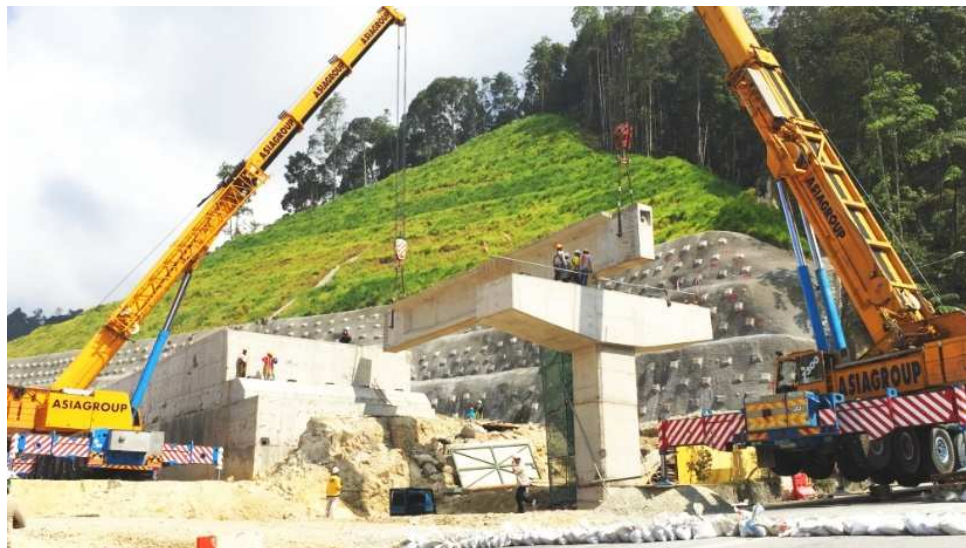
5. The construction of bridge across existing public road called for tightest supervision and safety control. A lot of attention was put in on the study of the bridge super elevation, gradient and details to ensure full engineering compliance. Since T-beam launching took place on the main road, therefore road diversion and launching sequence needed to be planned ahead since road closure was definitely not an option. The bridge was completed within 5 months period.

T-Beam Launching from Abut A to Pier 1

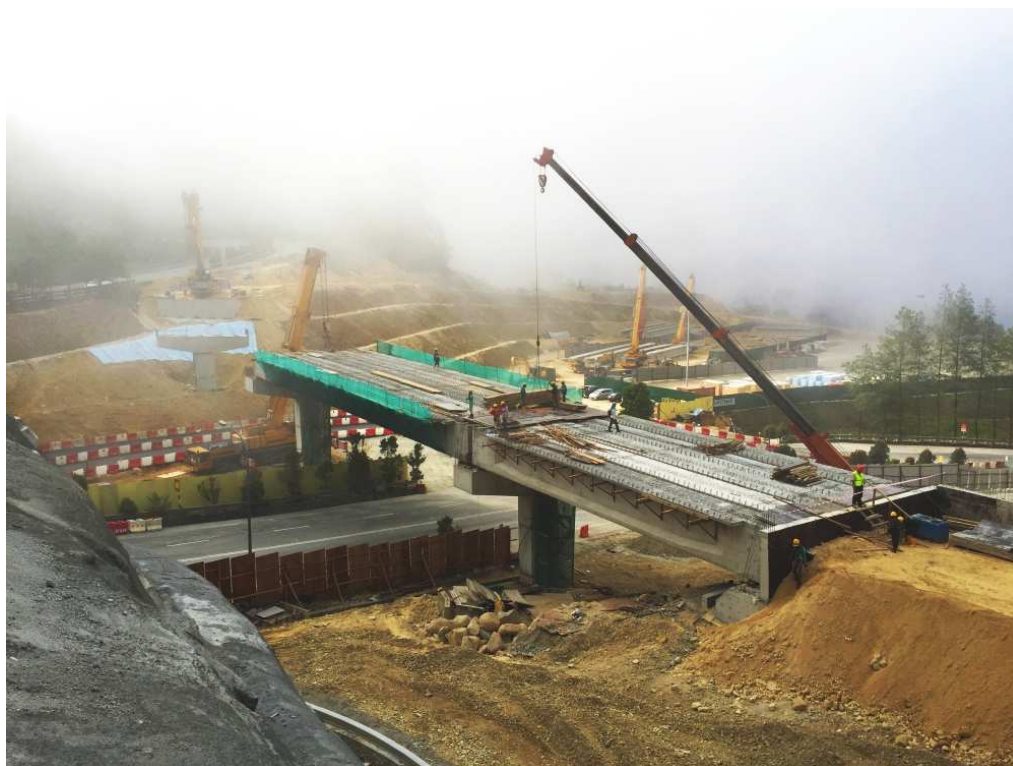
T-Beam Launching Progress Photo
