G501 – MK27 @ Mont' Kiara

Project Introduction

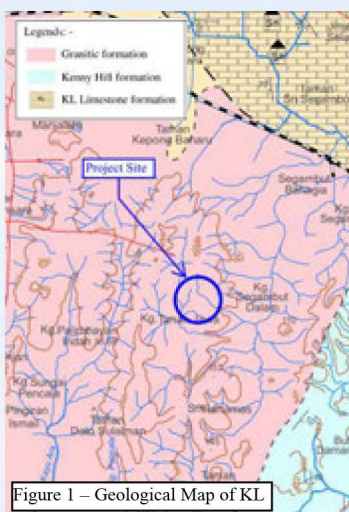
Figure 1 – Geological Map of KL

With reference to Geological Map of Peninsular Malaysia (**Figure 1**), the project is believed to be underlain by Granite bedrock formation with overlying residual overburden soils and was confirmed by 15 nos. of borehole.

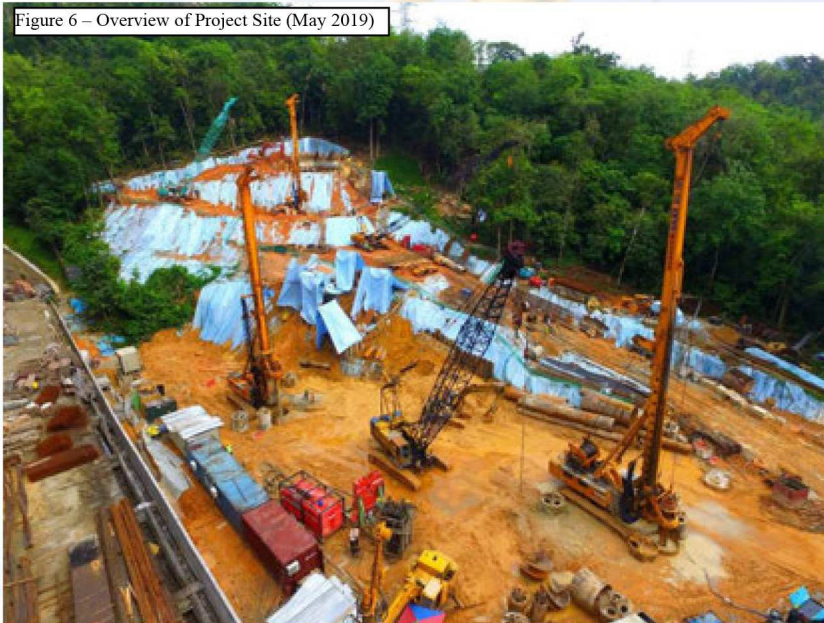
Figure 6 – Overview of Project Site (May 2019)

Site logistic planning was paramount for this project site due to diverse construction activities carried out simultaneously, limited working space, sloping terrain and shared access with adjacent construction site. The working space constraint was especially pronounced for construction of bored pile & CBP at higher level, approximately differs by 30 meters from lowest ground. The challenges were further extended to concreting works at elevated ground which was inaccessible for concrete trucks. For that reason, such concrete

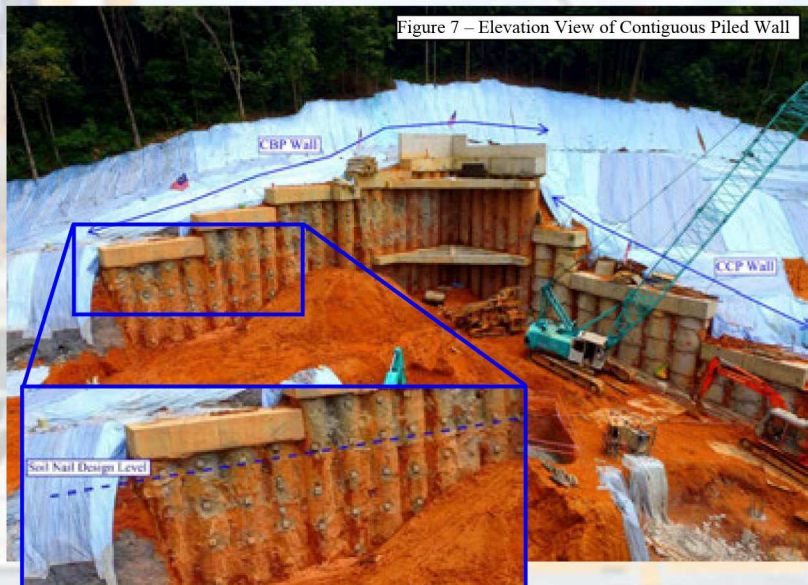
Figure 7 – Elevation View of Contiguous Piled Wall

works were either performed using concrete pump or concrete bucket lifted by crawler crane. Besides, quite some numbers of pre-fabricated soil nail pipe sleeve inside CBP wall were found to be deviated from the designed level upon exposure of wall excavation face. In the extreme case, some soil nails were even required to core through the CBP wall as the pipe sleeve was totally strayed. Other construction challenges faced by the site team includes bottom-up gunniting works of 12-meter CBP skin wall,
