## Ascencia @TTDI (On Construction Aspect)

### Earthwork Excavation and R.C.Works Within Struttred Diaphragm Wall

(by Mr. Keong Kian Huat, Project Manager) (2014 Jul-Sep)

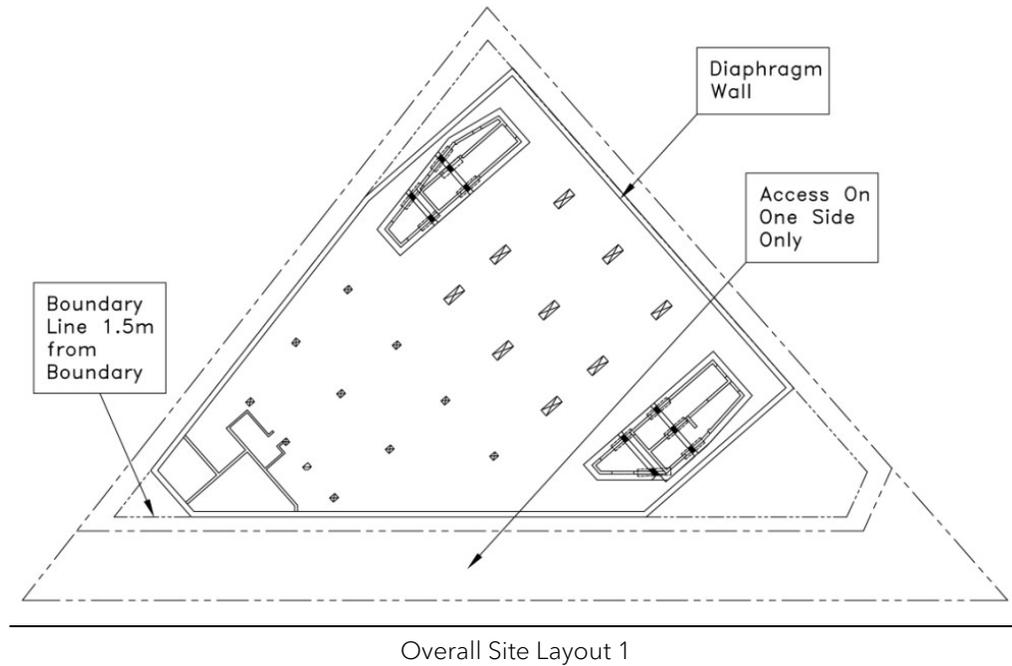
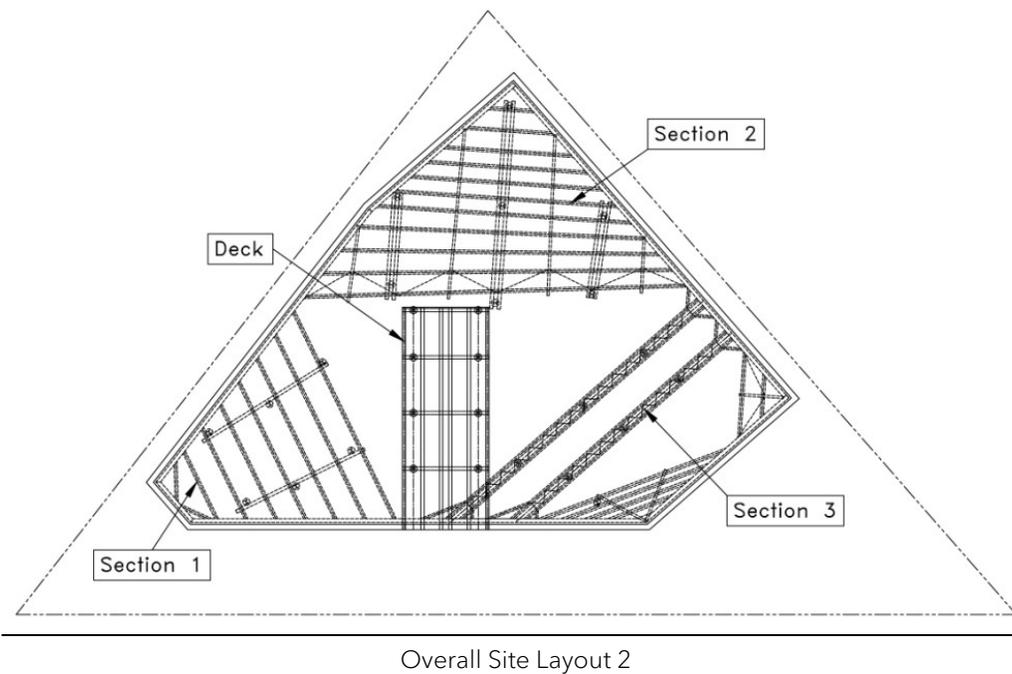
The land is triangular in shape and has an area that is approximately 3500 metres square. The basement built up area is roughly 2000 metres square. The setback line is only 1.5 metres away from the boundary making it accessible from one side only (see below). There is no circulation around the site as the hoarding is situated on the boundary line itself. The road reserve is the only area available for vehicles and construction plant to access the site. Due to the constrained nature of the site, the construction sequence had to be well planned. A deck was also proposed to facilitate the earthworks and reinforced concrete works for the basement construction.

Upon the completion of the diaphragm wall and bored piles, the earth was cut from the existing ground level of RL 46.5 to RL 42.3 (1 metre below strutting level). The struts were then constructed progressively in sections as indicated above. Upon the completion of the struts, a small excavator had to be deployed to remove earth from beneath the struts to the Basement 2 level of RL 37.6 The construction of pilecaps, Basement 2 slab,

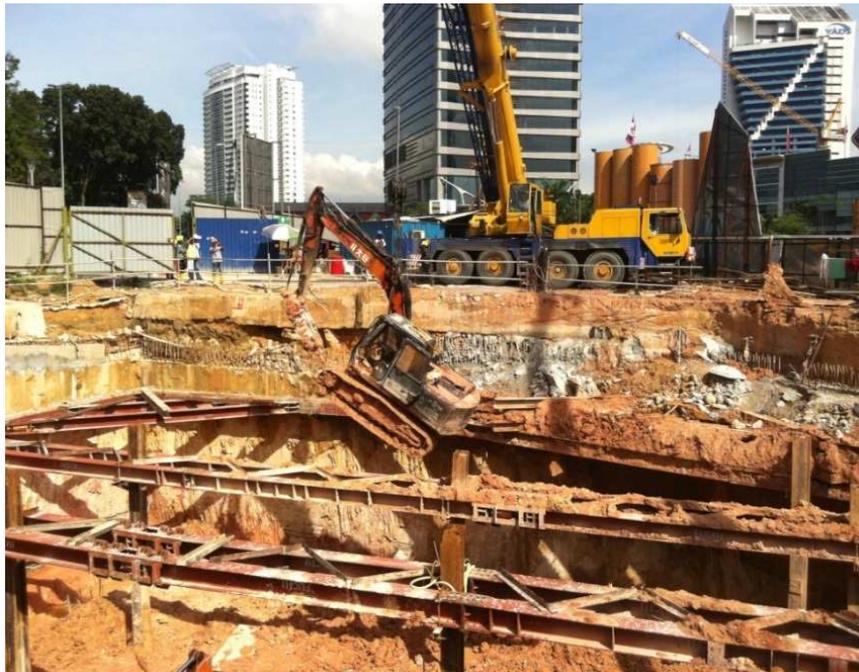
A small excavator had to be lifted out of the basement upon completion of the earthworks

Earthworks for the project was an activity that had the most problems. Firstly, the circulation around the site was non-existent. The site is small which made constructing a temporary earth ramp impossible. Earth was transferred out from Sections 1 & 2 with the use of the excavator only. This involved a lot of double handling and as such time and cost. Initially 3 excavators were deployed to carry out the works when cutting to the strut level. However, after the strut level, only a small excavator could be used since it had to work under the struts. Another excavator was deployed on top to transfer the earth into trucks which transported the earth out. The site was also getting more congested as works progressed from Section 1 to Section 2 and then Section 3, with the reinforced concrete basement construction works following in full swing. Trying to balance the cut and fill was another issue that had to be dealt with. The site was over cut slightly to compensate for the earth from the pile cap excavation which was still ongoing. Finally, the small excavator had to be lifted out of the basement upon completion of the earthworks. A 60-ton crane was used for the operation (see photo).
