Honda 3s Center @Melawati

The Proposed Design and Build Cantilever Caisson Wall At Honda 3s Center for Weststar Auto, Melawati, Ulu Kelang

(by Ms. Yap Fui It, Senior Design Engineer) (2011 Apr-Jun)

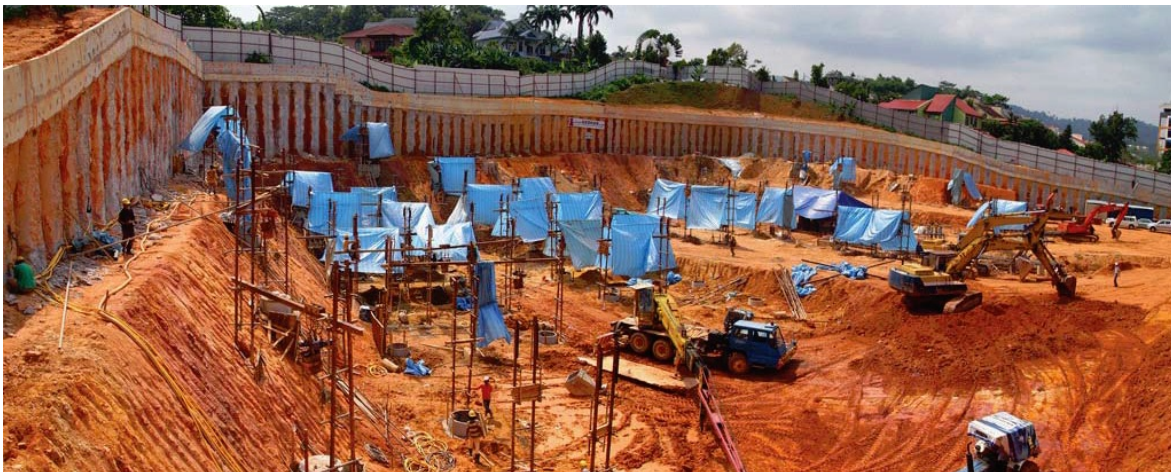
The site is located on sloping terrain, ranging from approximately RL70.00 to RL55.00 with basement excavation level at RL51.20 and the entrance is fronting the existing highway, MRR2 with road level of about RL54.00. The caisson pile wall was introduced at three sides of the boundary and act as permanent basement wall to facilitate the basement excavation. Due to the steep gradient terrain and sensitivity to the surrounding neighbourhood (close proximity to National Zoo), the original design of contiguous bored pile wall and bored pile building foundation may not be a cost effective and environmental friendly approach as compared to the alternative proposal.

In order to have the cost effective of wall design, semi-top-down construction method was proposed, except a corner of the wall portion with lower retained height is designed as cantilever wall and normal down-top basement construction is allowed. The proposed caisson wall consists of caisson piles spaced at 1.8m interval, and finishing of 150mm thick R.C. skin wall at the exposed surface. A temporary passive earth berm at RL59.40 was formed as a temporary support to the wall during excavation to lowest basement level. Subsequently, the ground floor slab will act as permanent wall support to the caisson wall with the maximum exposed height of 14.6m.

Finite Element method by using PLAXIS software is used to model and analyse the interaction between the soil and the retaining system to study the effects of the excavation to the surrounding ground and adjacent buildings. The predicted wall displacement on the pile top is limited to 75mm against the maximum exposed height of 14.6m. During excavation, weekly monitoring on the
