## Genting Mall @Genting Highland

### Soil Nail Tied-Back Caisson Pile Wall at Genting Mall

(by Ms.Yap Fui It, Asst Design Engineer) (2014 Apr-Jun)

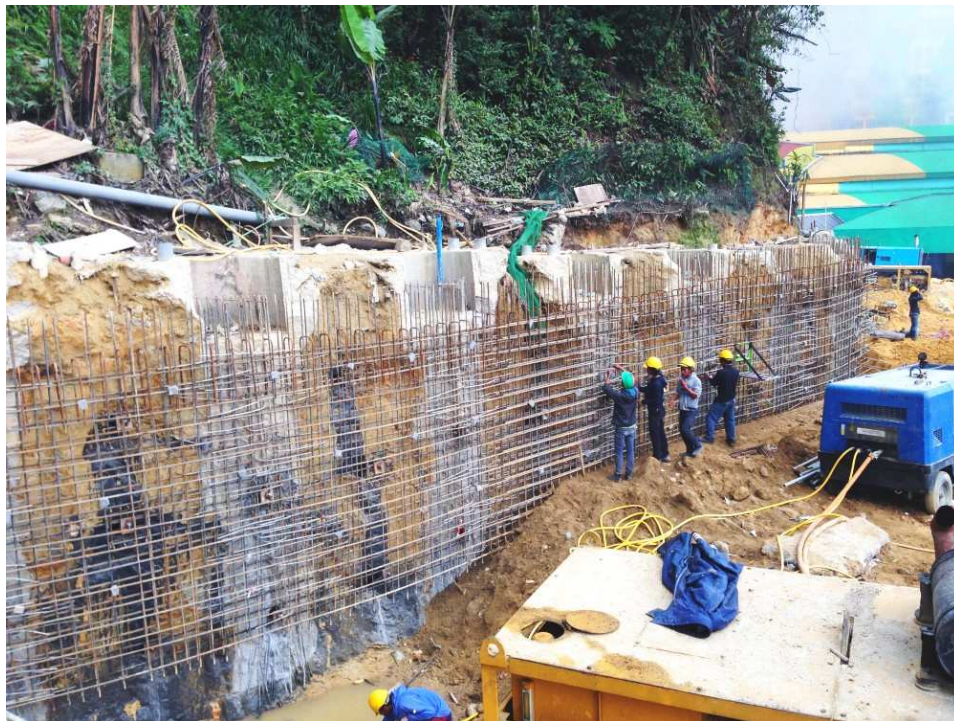
Figure 1: Fabrication of R.C.Skin Wall after the Earthwork Excavation in Stages.

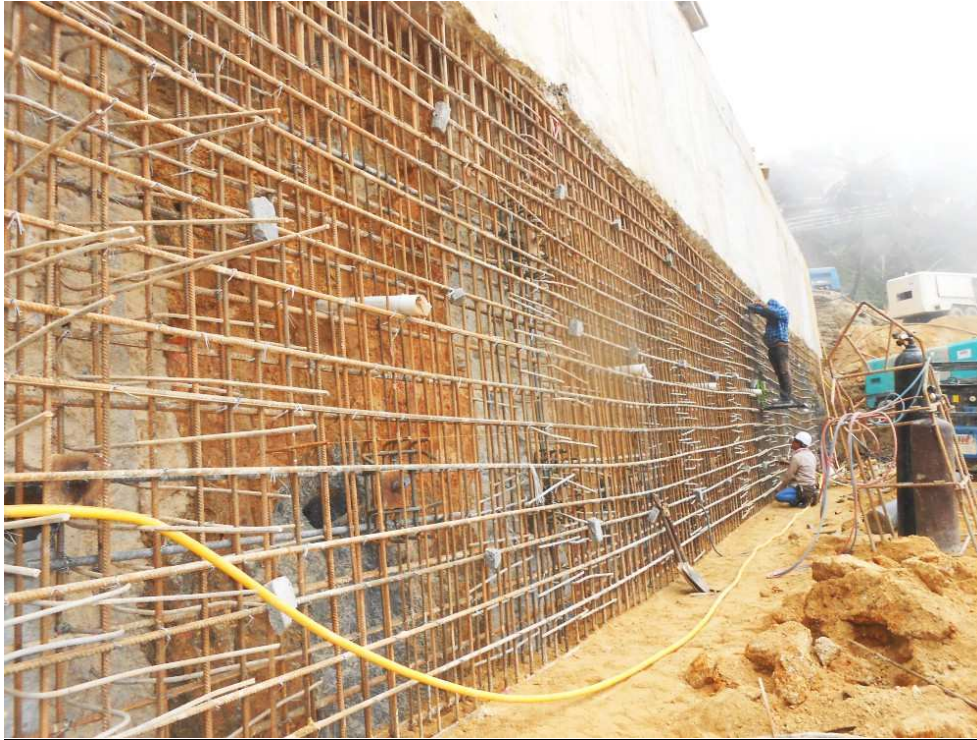
Figure 2: Construction of Skin Wall and Soil Nail Bearing Plate Installation.

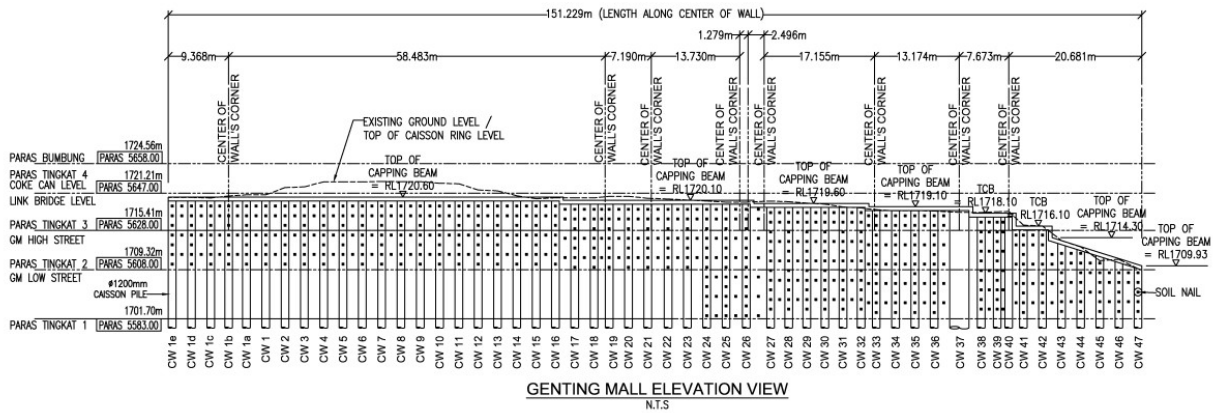
Elevation view of Tied-back Caisson Pile Wall

The soil nail tied-back caisson pile wall is designed by the project Consultant. Total wall length of 152m is formed by 52 nos. of 1200mm diameter of caisson pile with the spacing of 3m c/c, which is required to be socketed more than 3.5m into Granite bedrock. The first 4 layers of permanent soil nail to be installed are 18m length or minimum 3m rock socket into Grade III Granite bedrock with 1.5m spacing in vertical direction. The subsequent layers of permanent soil nail to be installed are 12m length or same criteria of rock socket length and nail spacing as above layer. Finally, a 300mm thick of RC skin wall shall be constructed in front of the caisson pile wall with embedding soil nail bearing plate within the concrete wall.

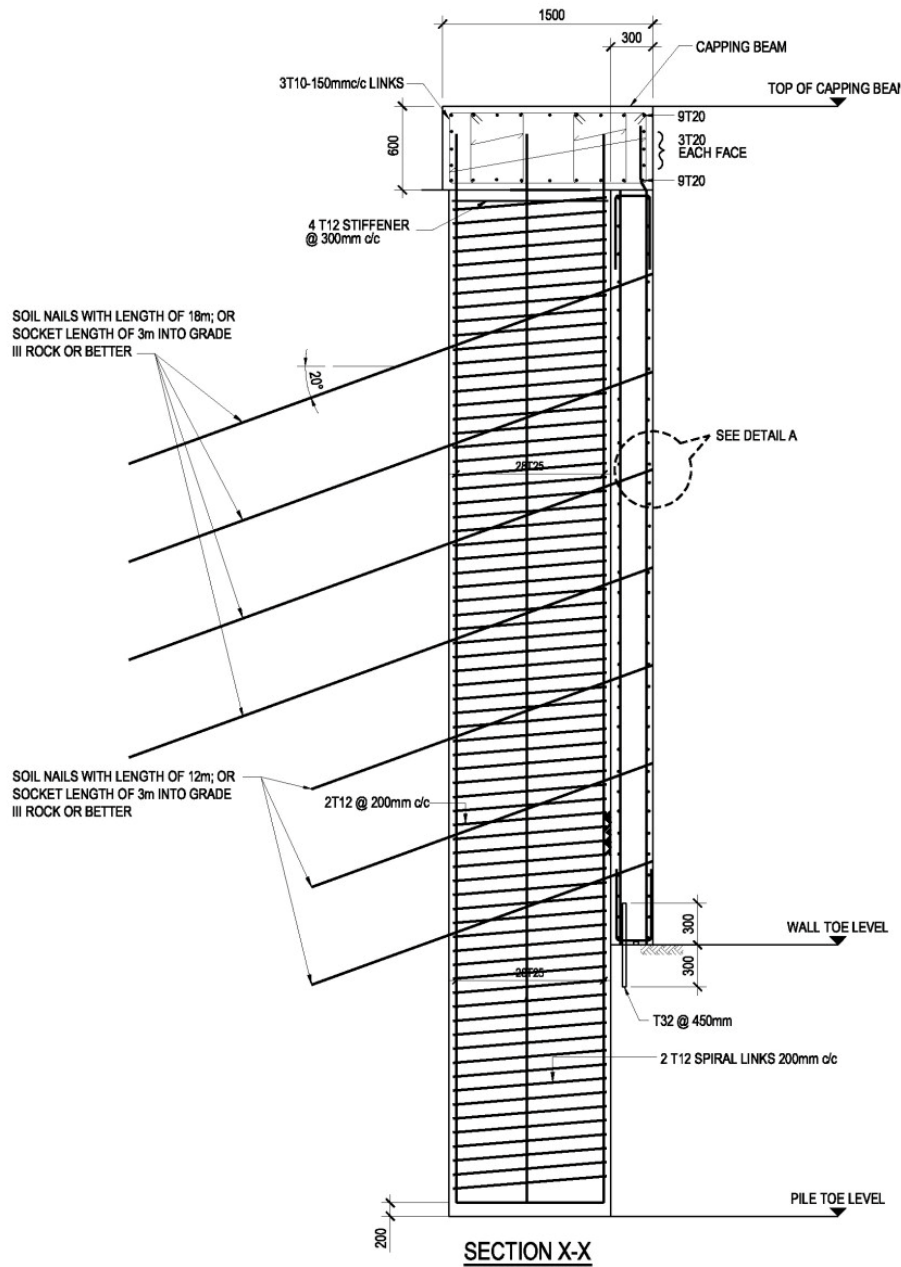
Figure 3 : Typical Section of Wall

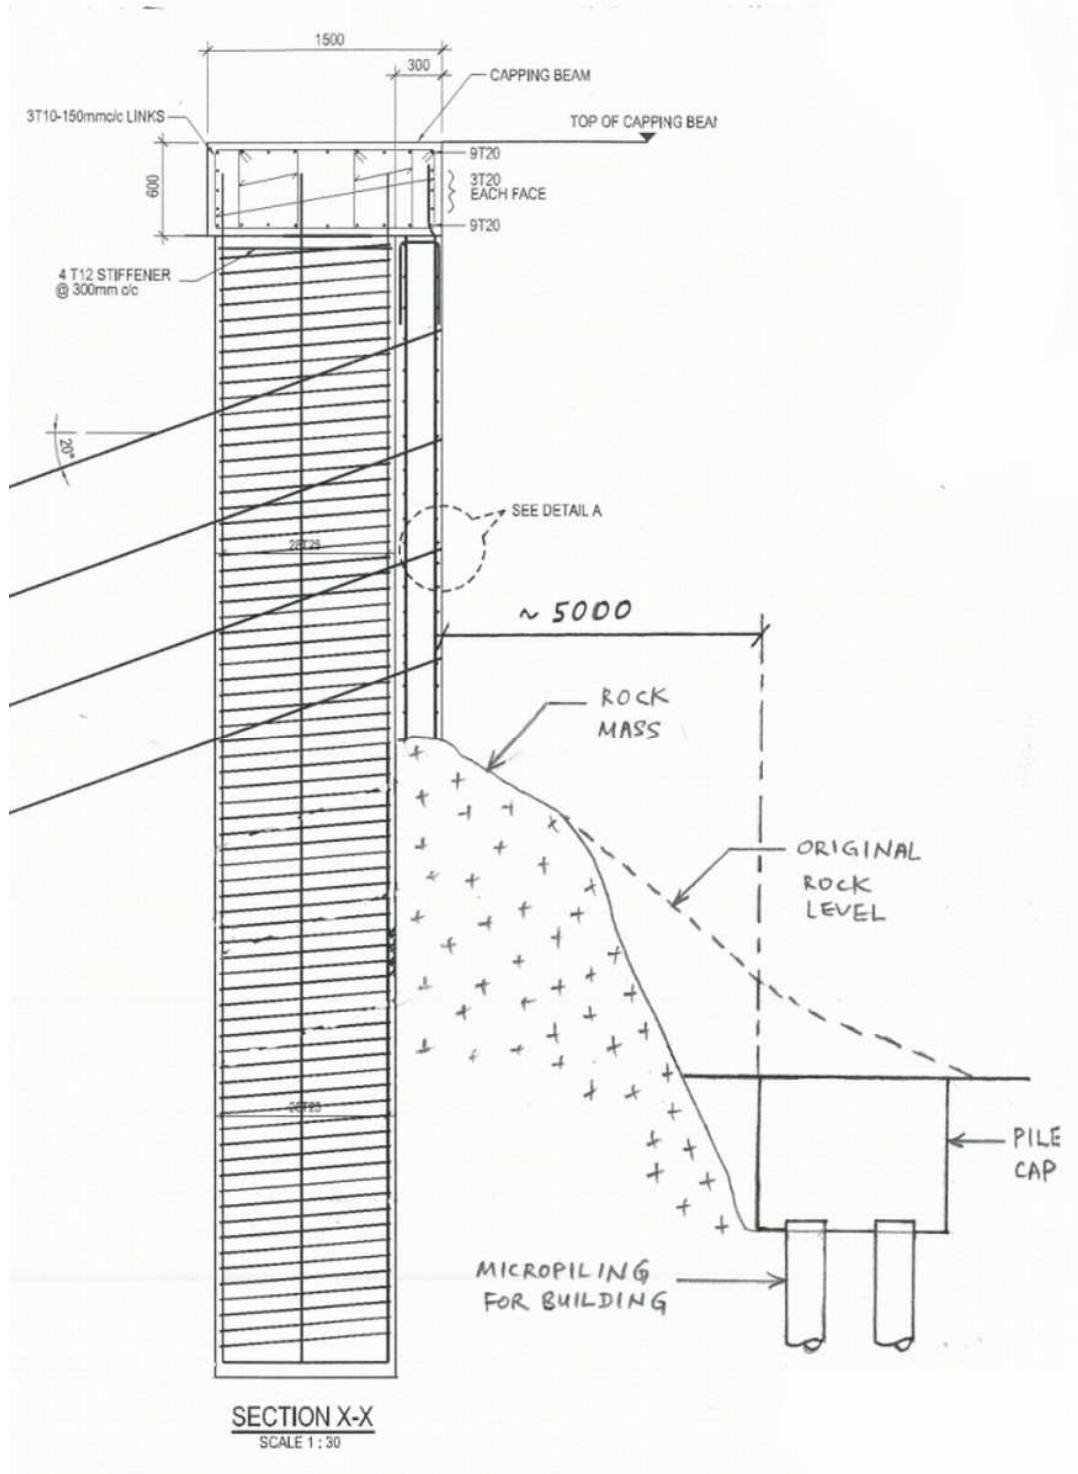
Figure 4 : Section of Wall Excavation When high Bedrock Level

The main challenge during caisson excavation was encountering higher level of Grade I or II bedrock, i.e. before the required design level in some of the caisson piles. The situation was resolved by shortening the rock socket length to cut down the caisson pile construction time. At the same time, maintaining a substantial rock mass in front of the wall as shown in Figure 4, upon consulting and approved by the Geotechnical Engineer, in order to prevent kick out at the pile toe level.

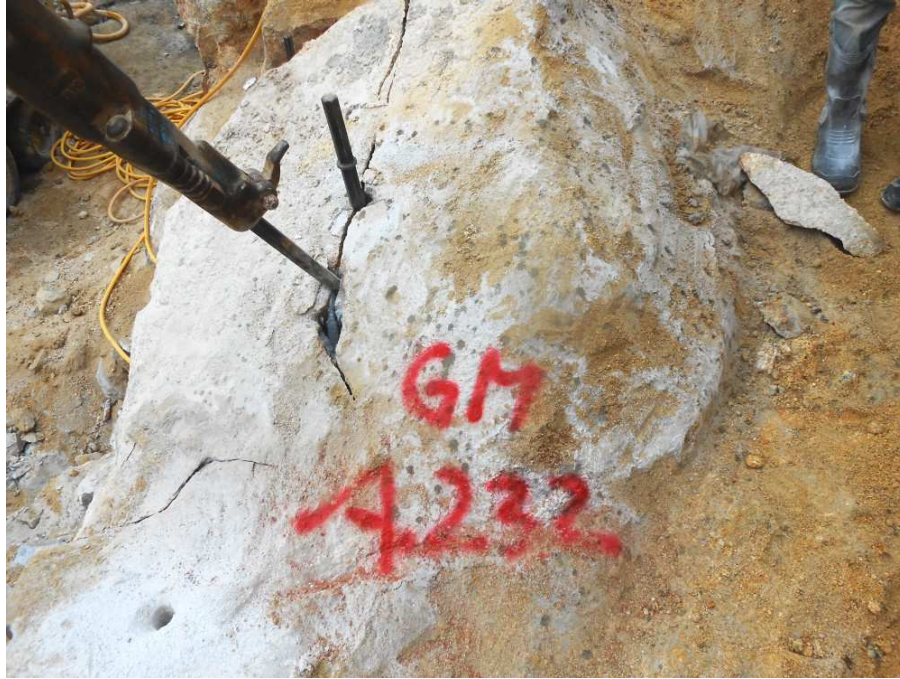
Figure 5 : Rock Splitting at Genting Mall

On the other hand, most of the overburden soil above the Granite bedrock is highly weathered Granite, i.e Grade IV, with boulders scattering around. Another challenge to face is during the mass rock excavation in front of the wall which required manual splitting and hacking, as shown in Figure 5 and 6.

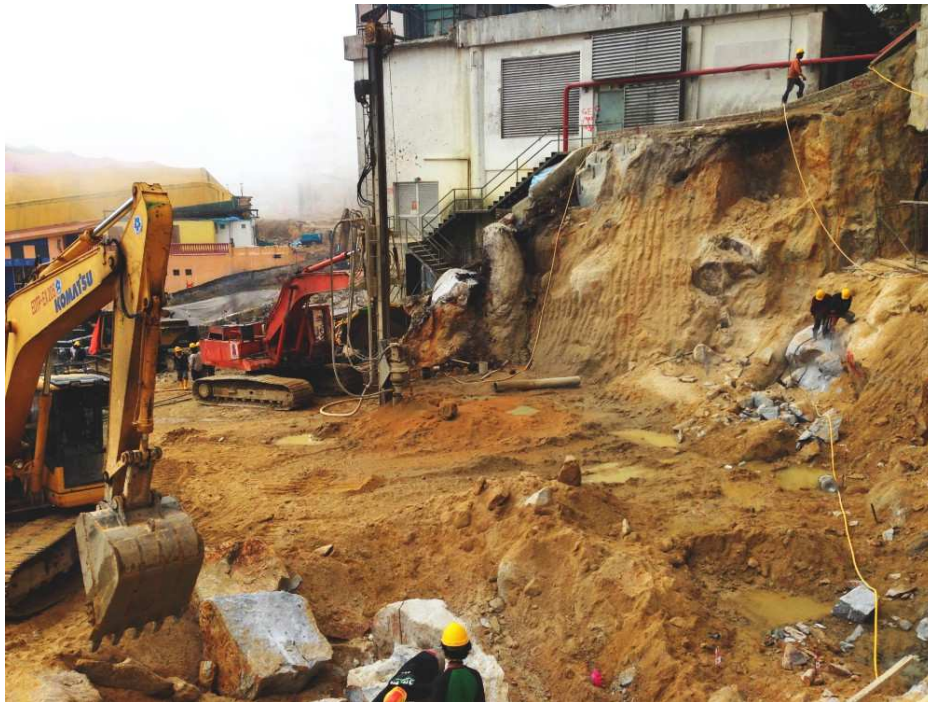
Figure 6 : Rock Hacking at Genting Mall
