Foresta 2 @ Sri Damansara

The Alternative Proposal of Caisson Pile in Deep Bedrock Zone

(By Mr. Patrick Lim, Sr.Project Engineer and Ms. Shairah, Design Engineer) (2017 Jan-Mar)

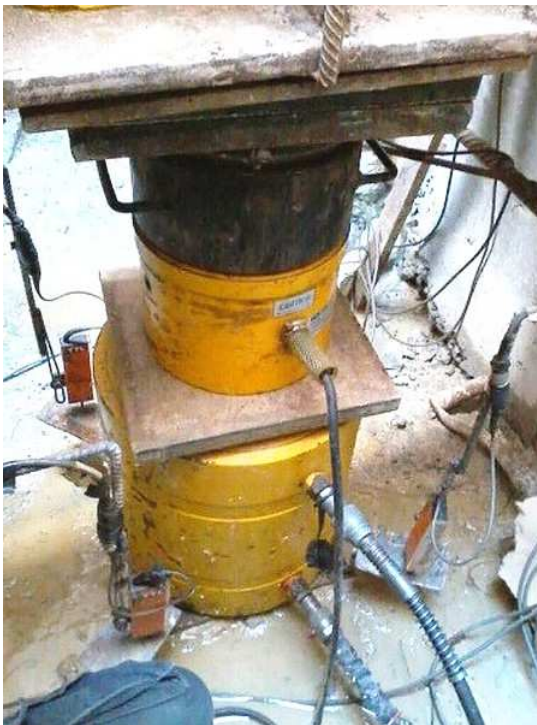
Figure 3 : Caisson Plate Bearing Load Test

From the instrumented test pile result, the ultimate rock skin friction was able to achieve greater than 1500kPa and ultimate end bearing capacity greater than 9000kPa (Grade III/IV). In addition, from the preliminary footing plate bearing load test result, it was verified that the footing ultimate bearing capacity of 6000kPa was acceptable. For caisson pile design which is founded into Grade II/III granite rock, the ultimate bearing capacity of 15000kPa was used and verified by the caisson plate bearing load test.

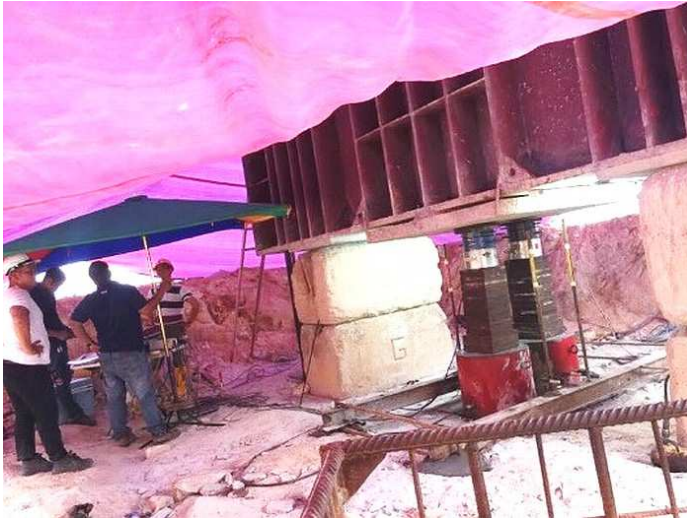
Figure 4 : Footing Plate Bearing Load Test

There have been are 1nos. of instrumented MLT on CP1000, 1 nos. of subsequent MLT on CP1500, 1 nos. of preliminary footing plate bearing load testing, 2 nos. of caisson plate bearing load test, 3 nos. of working footing plate bearing load test and 2 nos. of pile PDA testing in total. All test results were in compliance with the minimum factor of safety of greater than 2.0 in geotechnical capacity.

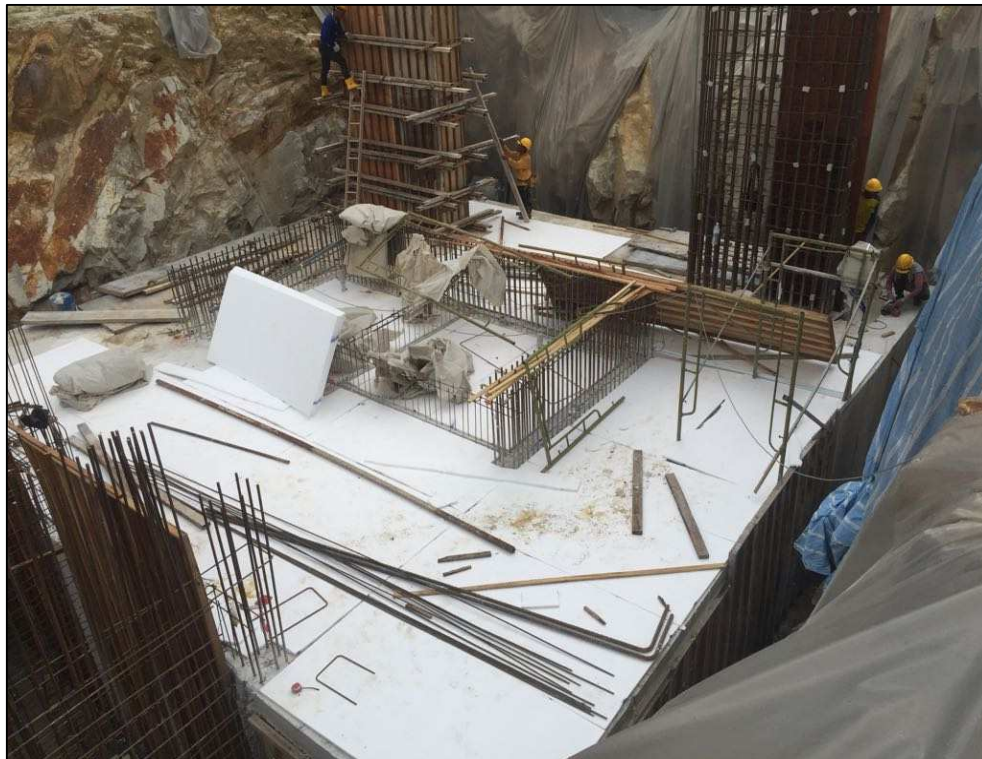
Figure 7 : Insulation Done on Footing LC3

Concrete temperature monitoring was conducted in LC3 to ensure engineering compliance in thermal crack control in a mass concrete structure. A special concrete mix with ice cubes was designed and used to fulfil the Engineer's

requirements. Formwork is a good insulator and therefore it was left in place after the pour for 48 hours. Whereas on the surface, a polythene sheet was laid and covered with polystyrene board to delay the surface cooling. Water pumps were standby on site for dewatering (in case of rain) to prevent surface rapid heat dissipation.
