Westside One @Desa Parkcity

Caisson Pile and Footing Foundation Solution on Rock Formation

(by Mr. Lai Chee Yong, Project Manager) (2010 Oct-Dec)

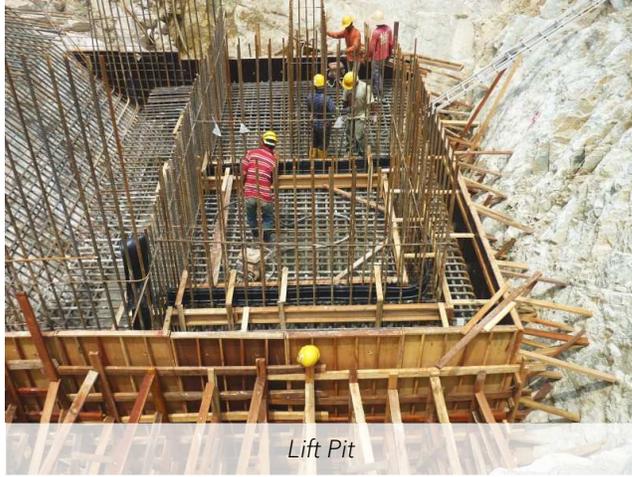
This combination of footing and caisson pile foundation system possessed concern to the consulting engineer in view of the differential settlement due to the different bearing stress level of the 2 types of foundation. After sessions of discussion and validation from the plate bearing test carried out, we eventually got the green light for sunken footings and some deeper caisson piles to limit the bearing stress to 1500 kN/m².

During the construction stage, we discovered that the rock level is actually higher and the granite is of better grade despite the natural fissure of the rock. Thus, we took a step further of changing partial of the remaining foundation to footing.
