## YTL Bangalow @Bukit Tunku

### Proposed Design & Build Soil Nailed Caisson Wall.

2 Storey Bangalow with 5 Levels Basement at Jalan Cerunan Tungku, Bukit Tungku.

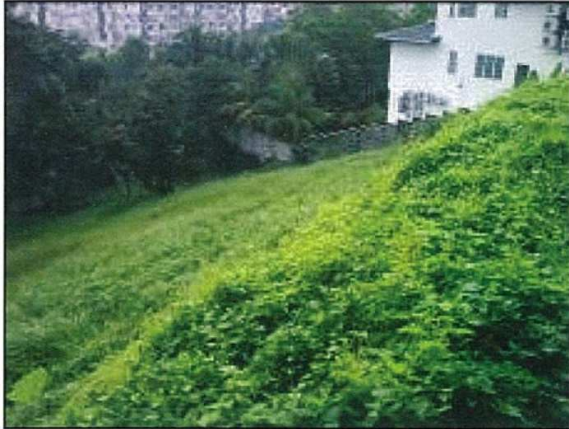
the proposed bungalow site is located at steep gradient of natural slope. Three sides of the boundary are surrounded by existing bungalow and the proposed entrance is fronting the existing paved road. The existing road level is at RL 62.50 and sloping at approximate gradient of 45 degree towards the back of the site at the toe level of RL 39.50. the difference between the highest and lowest level is 23m which posed a huge challenge in term of construction and technical design.

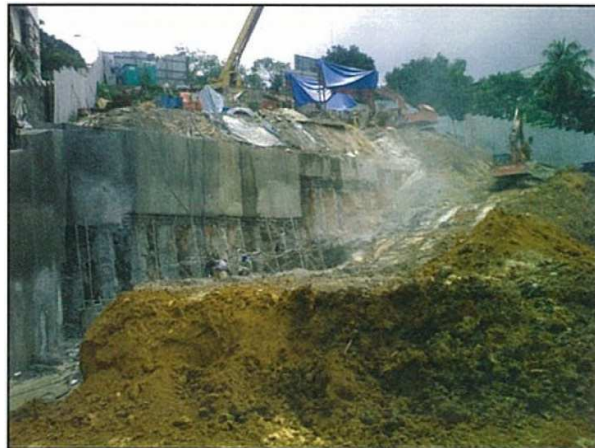
Due to the steep gradient and involve deep excavation to form the final platform level the original design of contiguous bored pile wall with ground anchor tied back was being replaced by caisson wall with soil nail tied back. The stages of platform excavation were planned and carried out in tandem with the caisson wall construction, as well as the installation of soil nail in every layer.

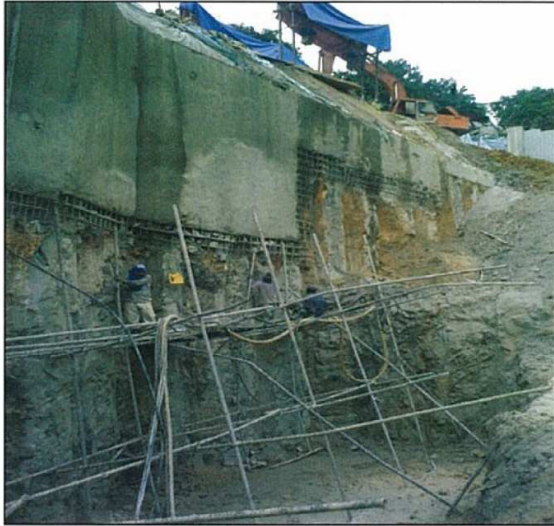
In order to form the final platform level at RL41.50 against the existing road level at RL62.50 with the difference height of 21m, 2 tier caisson walls were introduced at 10m and 11m cantilever height each. The first row of caisson is designed to the size of 1500mm in diameter and spaced at 2.0m c/c with 10m cantilever height and embedded to the ground in 14.5m depth. Whereas, the second row of caisson is designed to the size of 1200mm in diameter and spaced at 1.8m c/c with 11m cantilever height and embedded to the ground in 11.5m. in order to minimize the

displacement of caisson wall at second row, 5 layers of 12m length of soil nails were installed at the spacing of 1.8m c/c in between the caisson piles.

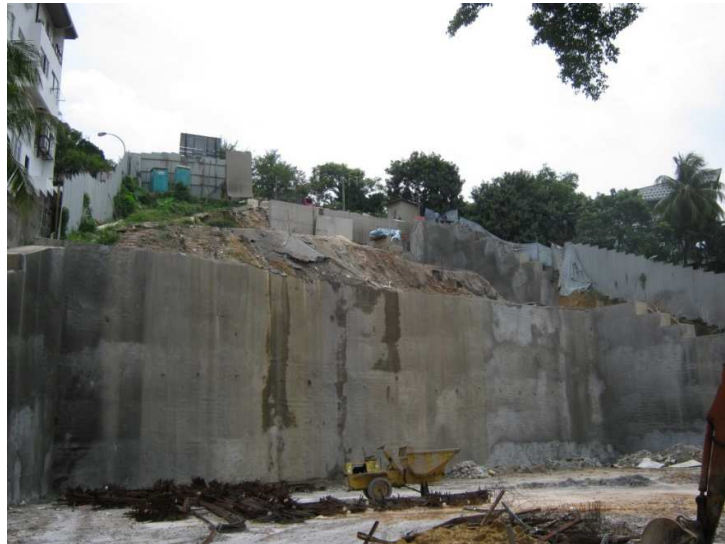
The construction of the multi-tier caisson wall and excavation to the final platform level was completed within the stipulated time successfully. The displacement of the caisson wall and the ground settlement behind the caisson wall was being monitored regularly and no sign of distress and only insignificant wall displacement being register. There were no complaints from neighbors during construction activities

and the disturbance has been successfully reduced to the minimum. We can concur that hand-dug caisson is an ideal solution when come to the hill slope development.
